# **Testing Requirements for Refractory Materials**

# Testing Requirements for Refractory Materials

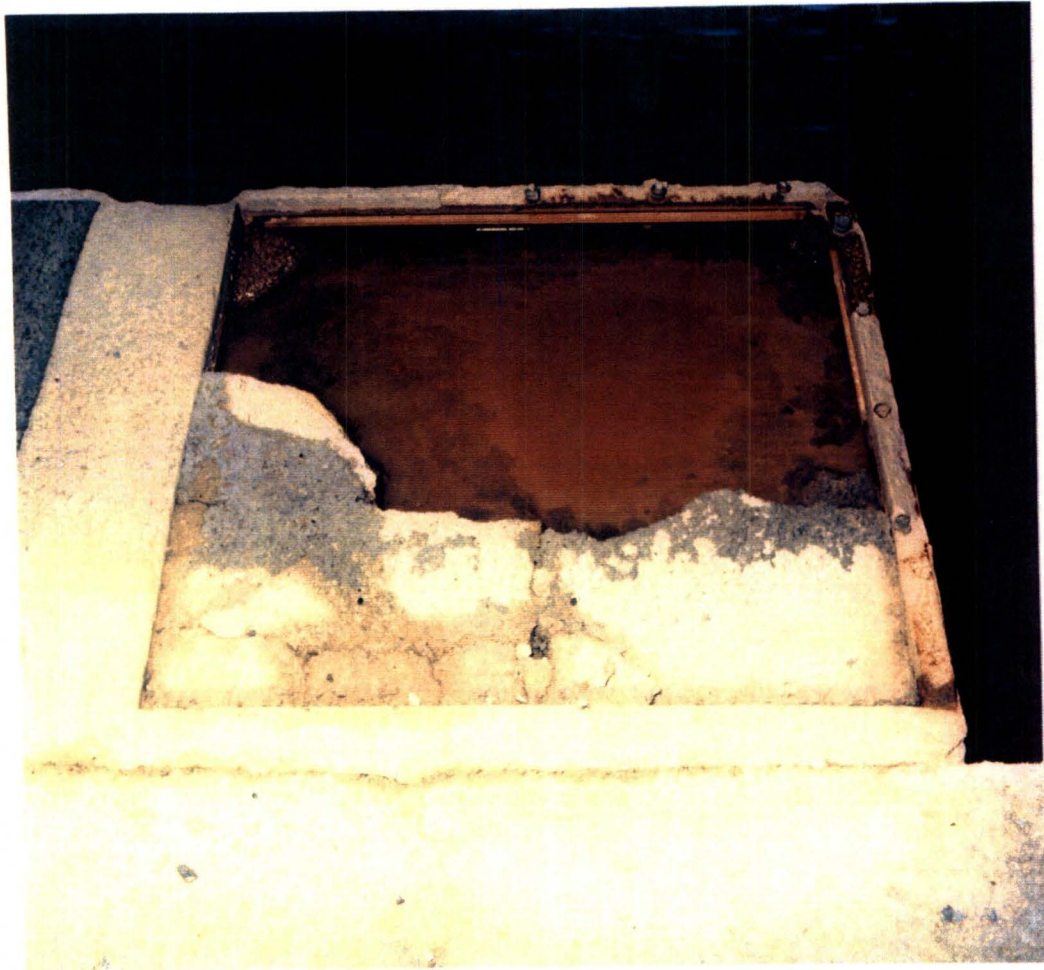
FIGURE 5

MITEC TEST SPECIMEN AT LOCATION "D" AFTER LAUNCH. OVER HALF OF THE TEST SPECIMEN WAS MISSING AND THE REMAINDER CONTAINED NUMEROUS CRACKS. AREAS OF HEAVY EROSION PITTING WERE NOTED ON THE FACE ADJACENT TO THE FLAME DEFLECTOR. THE SURFACE OF THE SPECIMEN APPEARED TO BE COATED WITH A ROUGH METALLIC LAYER EXCEPT IN THE AREAS OF THE PITTING.
